DRAFT Analysis of Brownfield Cleanup Alternatives

Pullman Yard
225 Rogers Street, Atlanta, DeKalb County, Georgia

March 22, 2019

Prepared for:
City of Atlanta
EPA Cooperative Agreement BF-00D59517-0

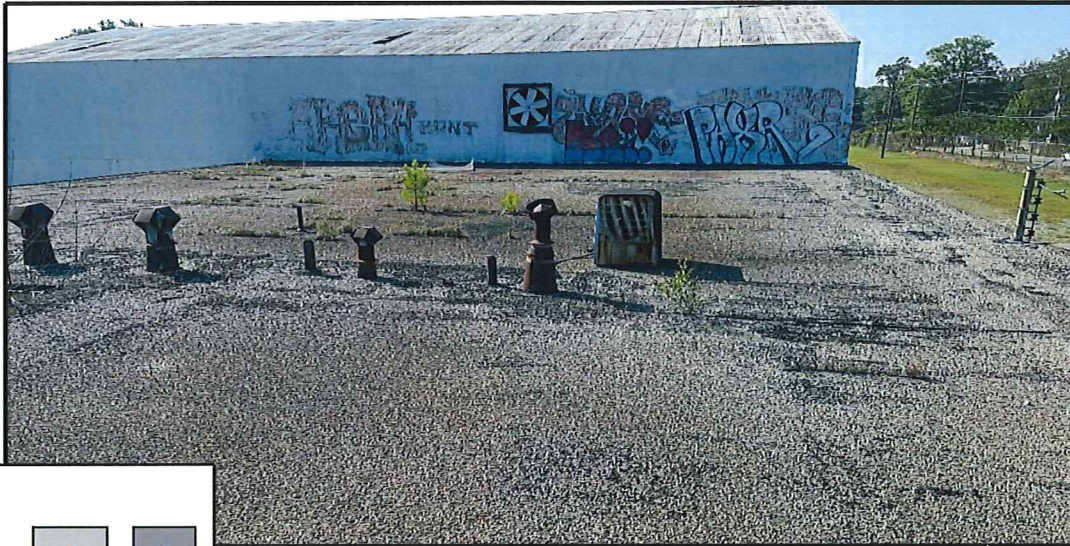
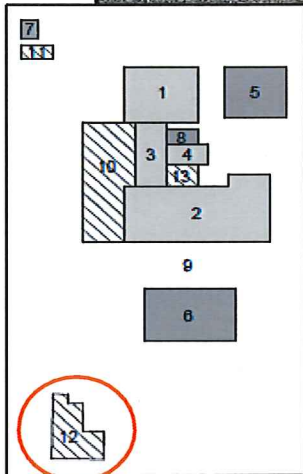
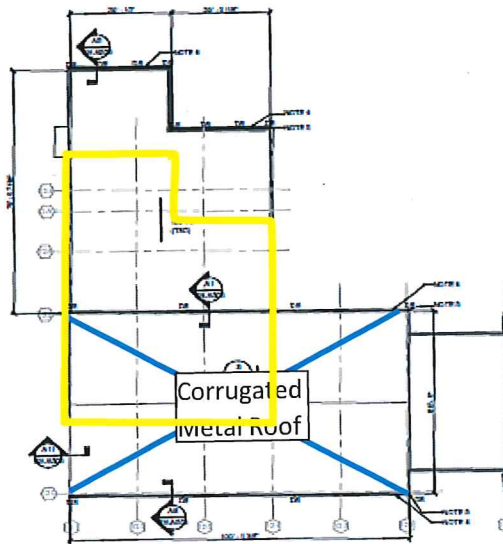
Building 12 – Outside Roof

Building 12
Asbestos
Roof Sealantg

Asbestos roof sealant - asbestos

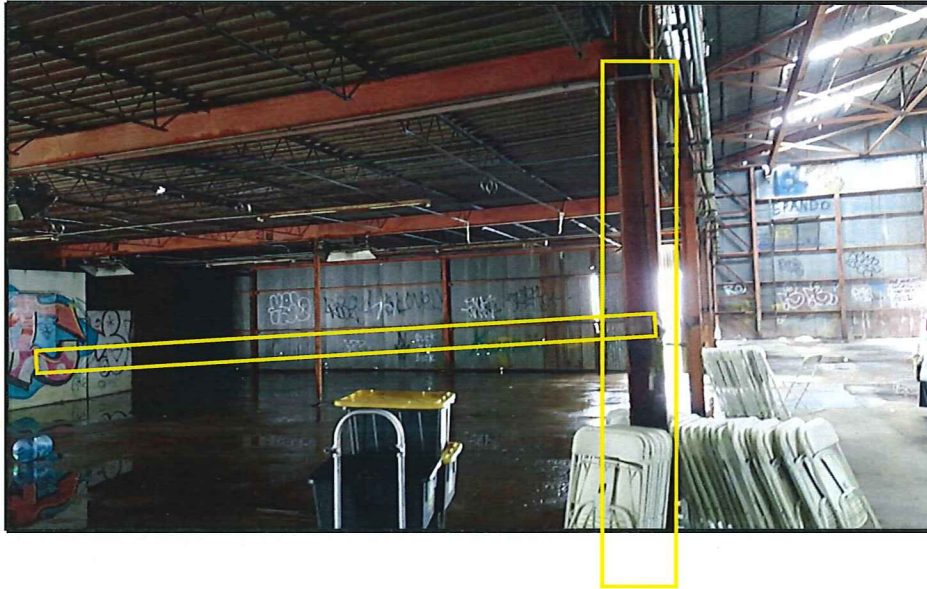
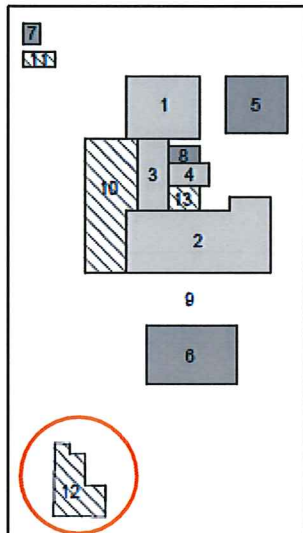
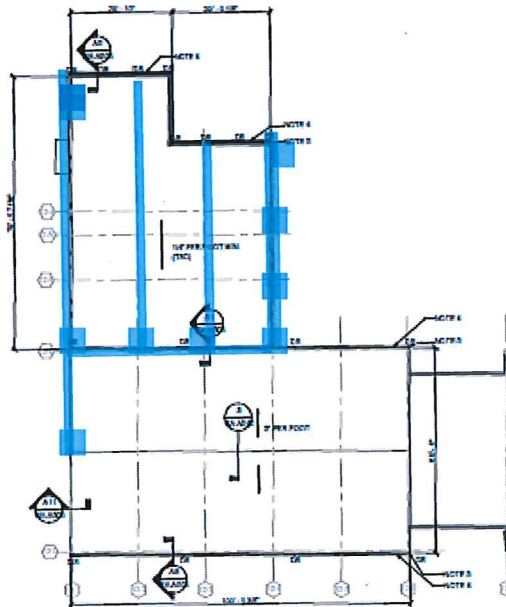
Building 12 Inside – Lower section

Steel beams (lower sections)

LBP – vertical and horizontal, steel supports, orange I-Beams (mostly in the lower roof section).

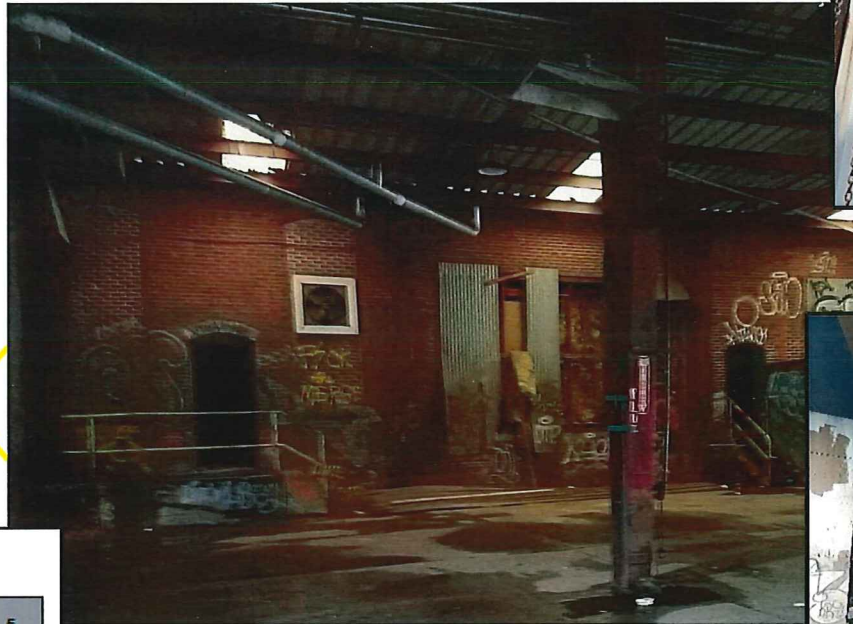
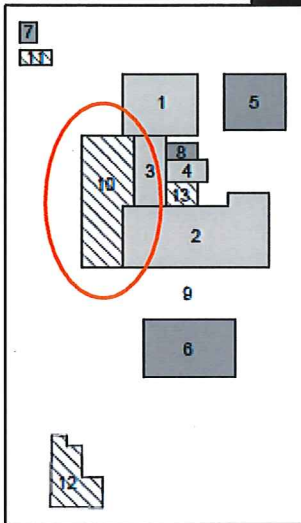
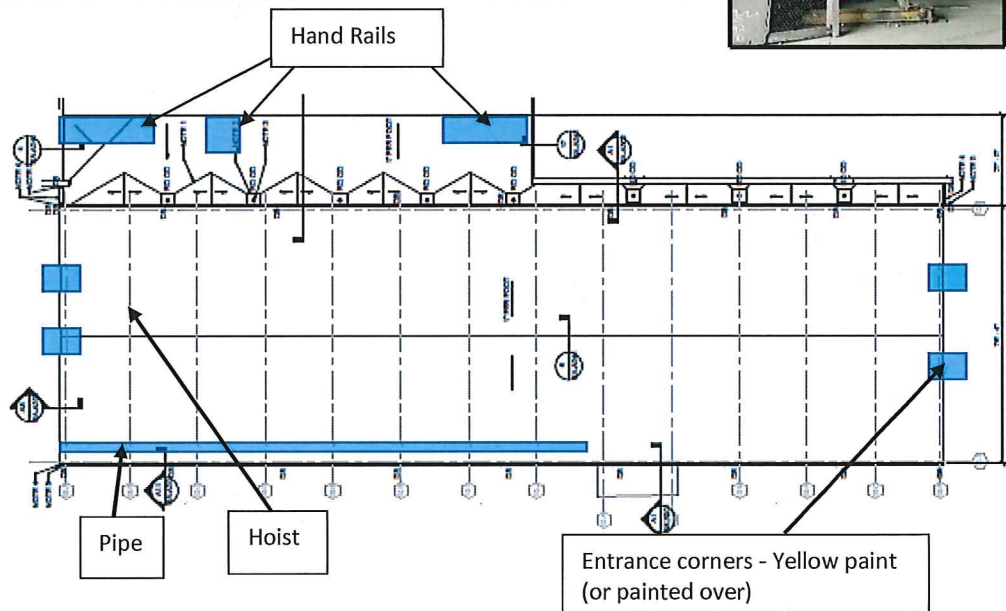
Building 10: Inside -

Yellow Hand Rails Hoist, and Entrance Corners

LBP – Hand Rails - Painted Yellow – (Three sets of rails, Estimated: ~125 linear feet), Hoist, Water pipe (yellow paint) along west wall (Estimated: ~ 120 linear feet) and the Posts/corners at entrances on north and south ends (note yellow paint).

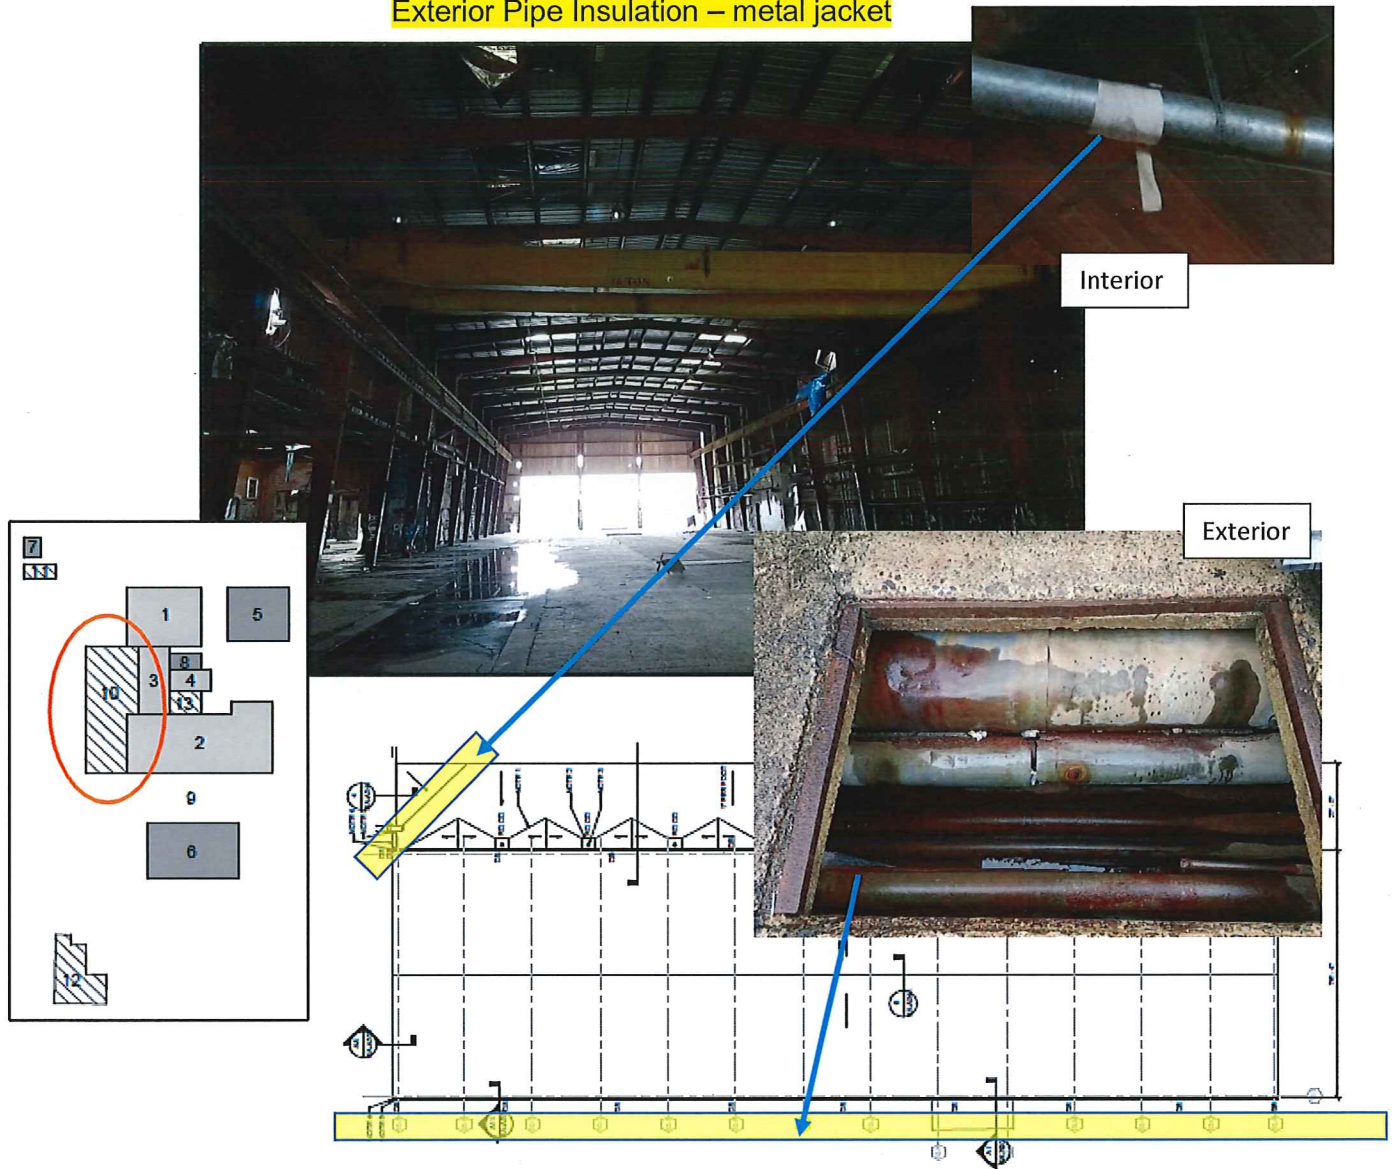
Building 10 - Inside

Interior Pipe Wrap

Exterior Pipe Insulation – metal jacket

Pipe Wrap - two joint spots.

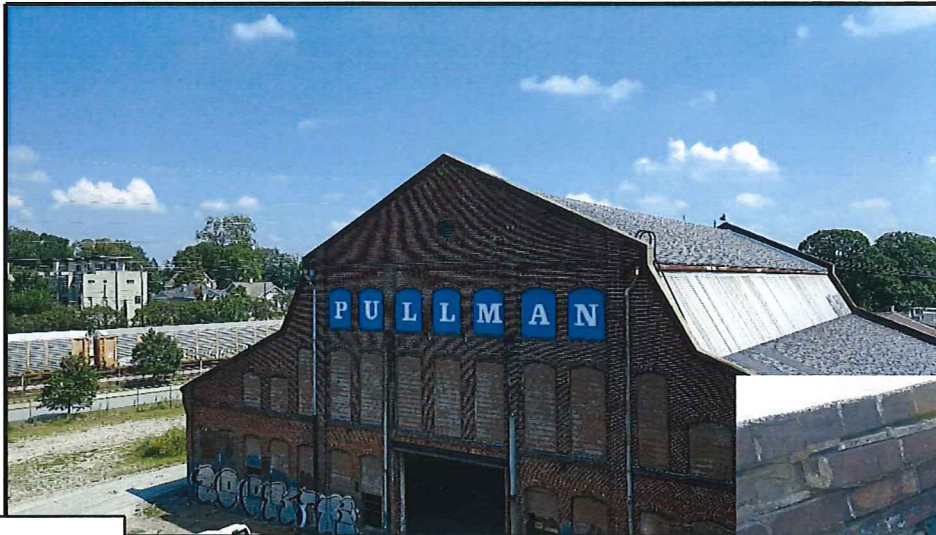
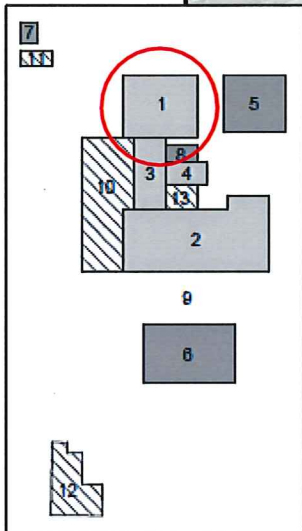
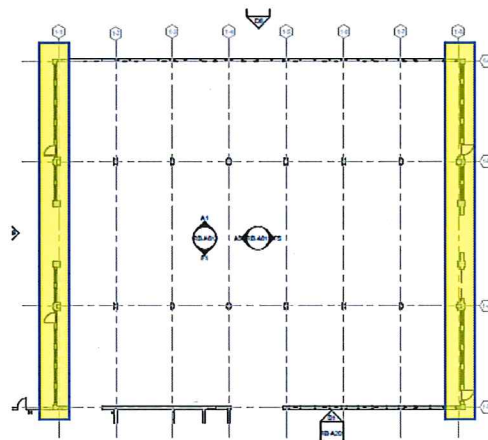
Building 1 – Outside

Roof Sealant (Flashing along edge and sealant)

Asbestos roof sealant along flashing paper.

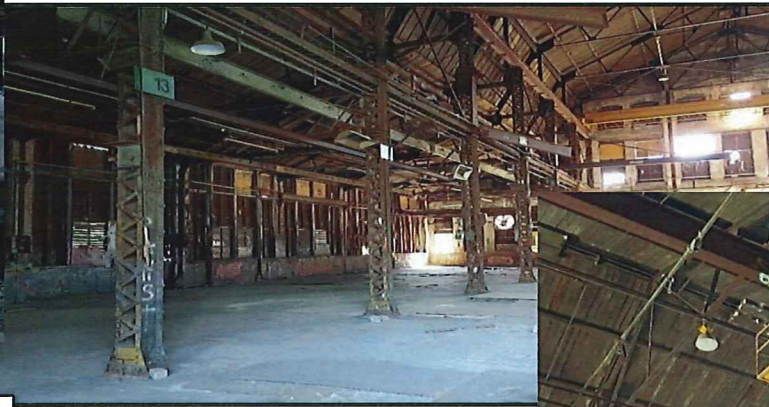
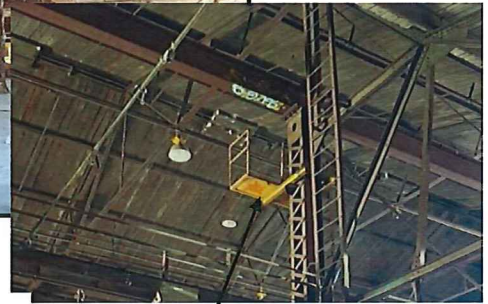
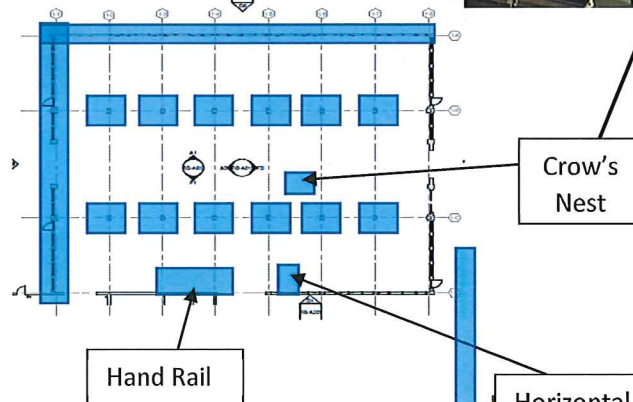
Building 1 – Inside

Steel columns, crow's nest, hoist arms, lower wall, window jambs, yellow rail

(12 - vertical, painted, lattice post – the lower 10 feet only).

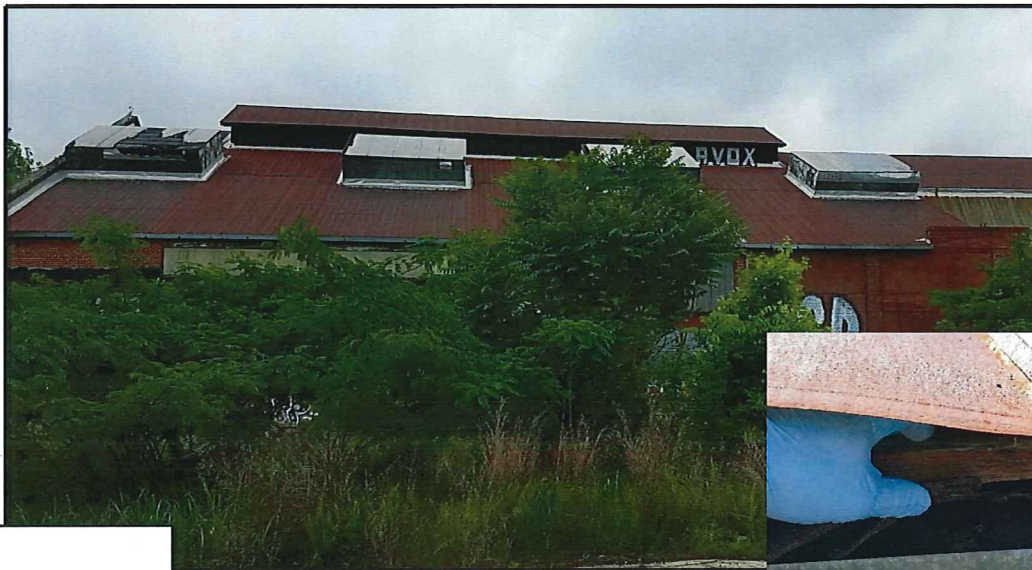
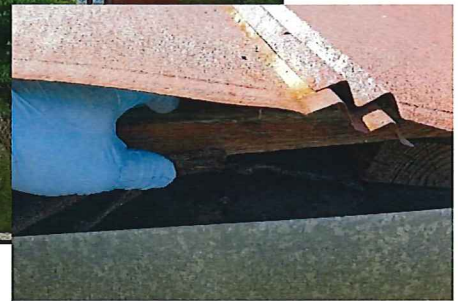
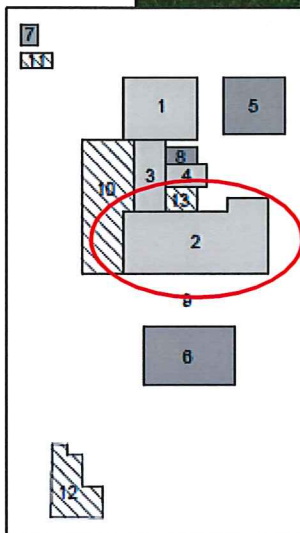
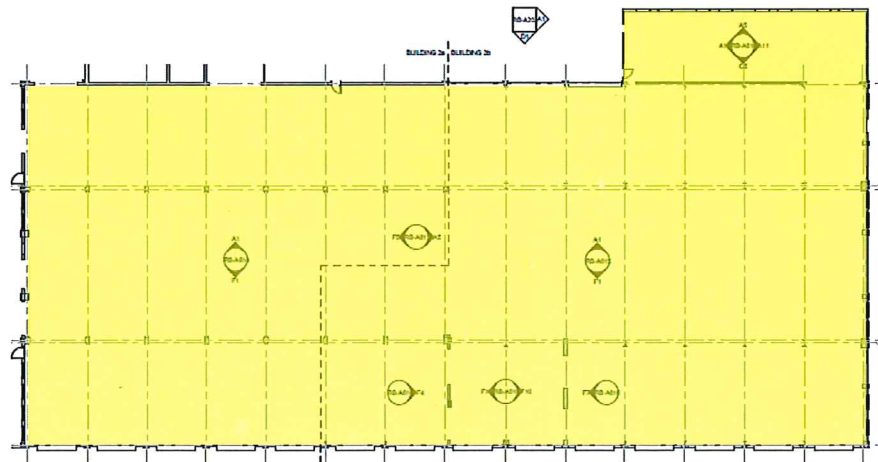
Building 2 - Outside

Roofing Felt/Paper

Asbestos roof flashing, sealant, and tar paper.

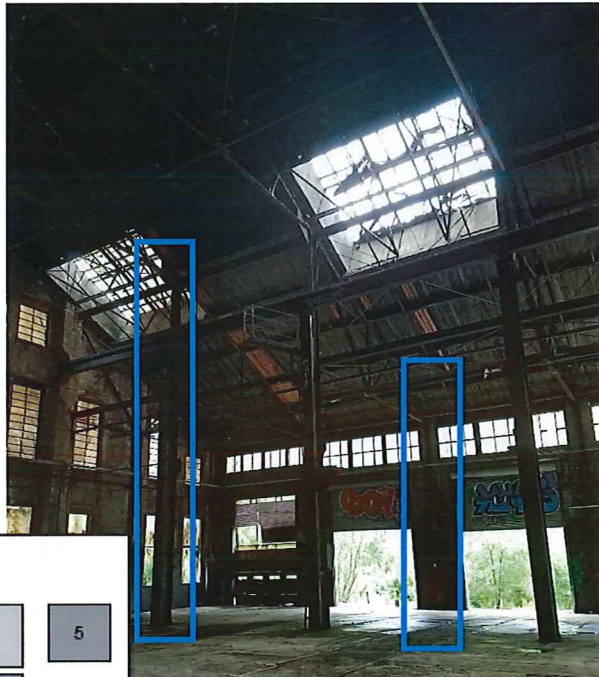
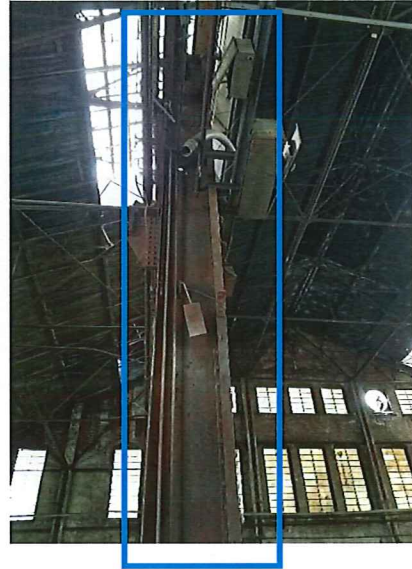
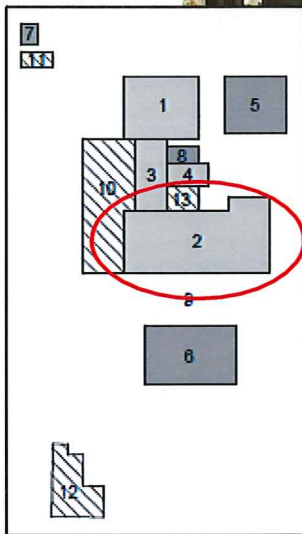
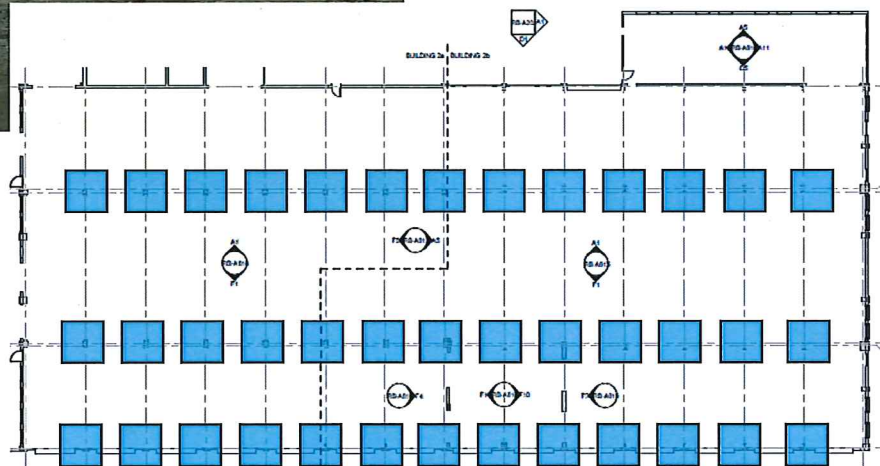
Building 2 - Inside

Interior metal vertical beams

39 Vertical lattice beams – full length.

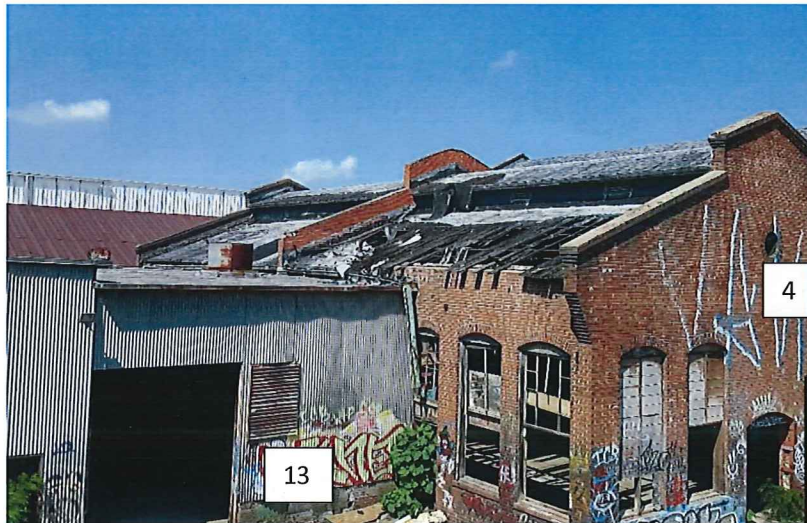
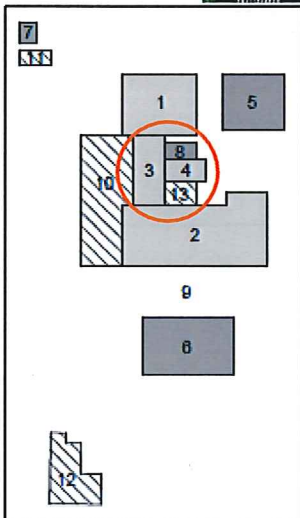
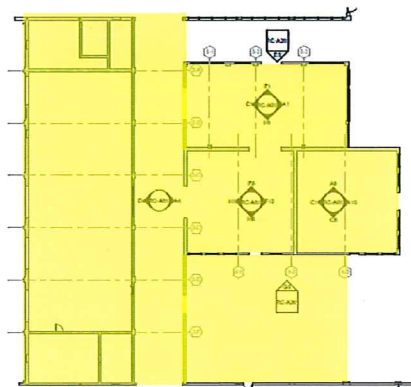
Roofing System

Building 13 is a flat roof – the Roofing system is Asbestos.

Estimated: Building 13 Area ~ 3040 sq. ft.

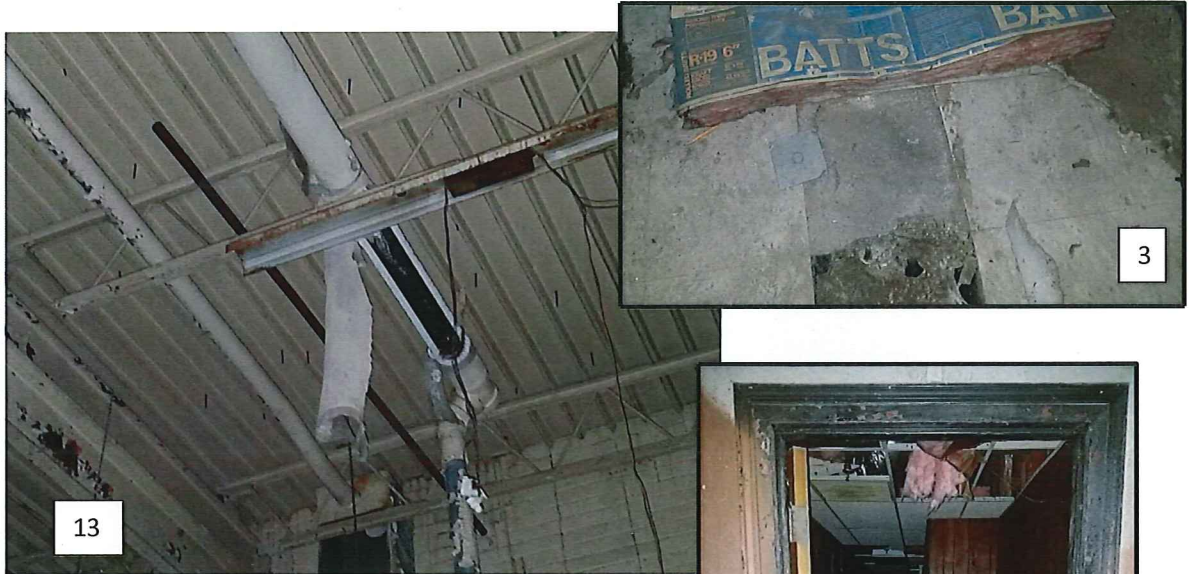
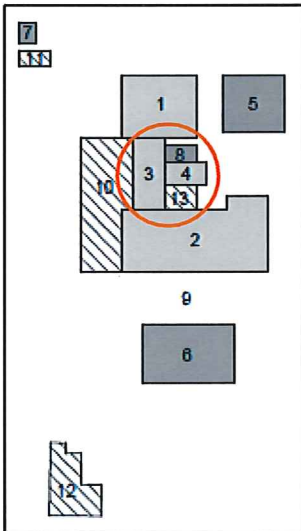
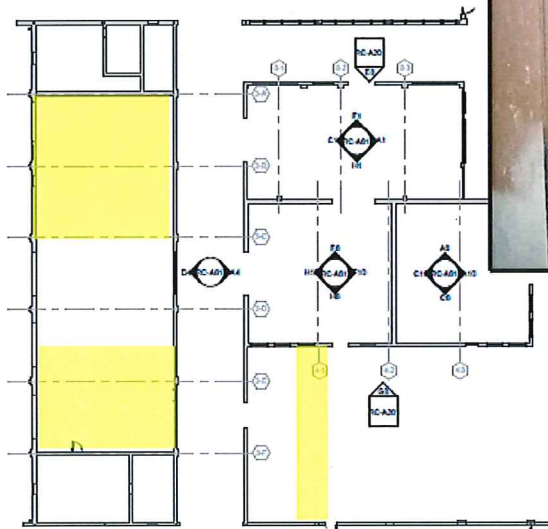
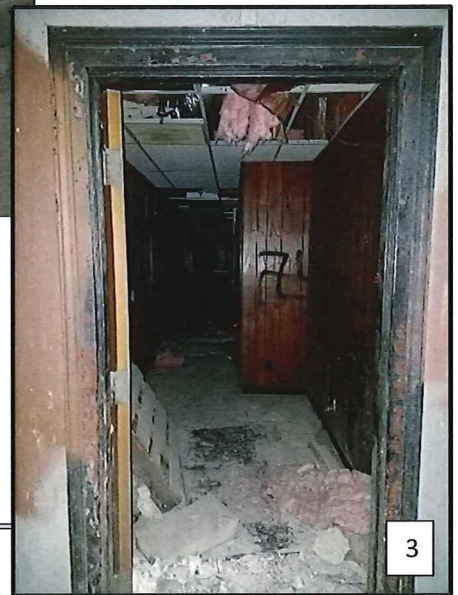
Building 3 – Inside

Floor tile, Pipe Insulation

Office area has asbestos floor tiles, mastic, and asbestos paper under the floor tile.

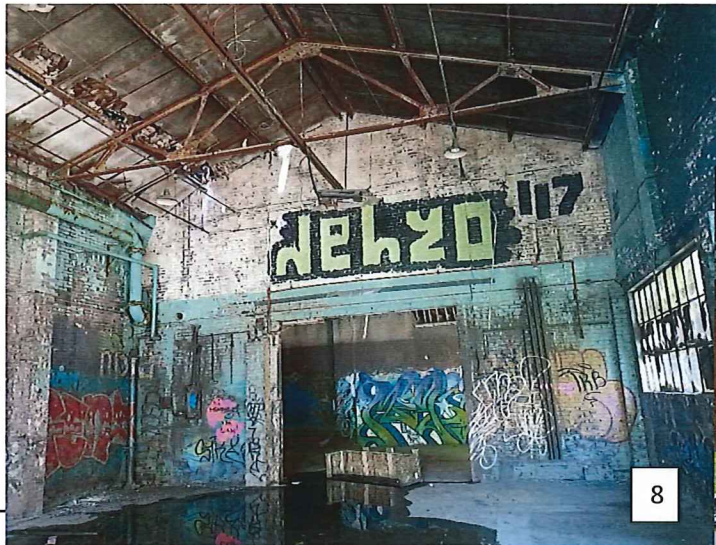
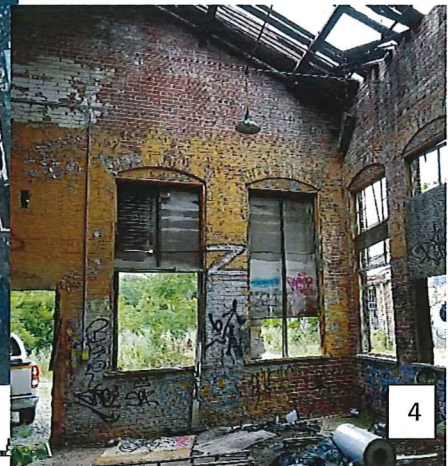
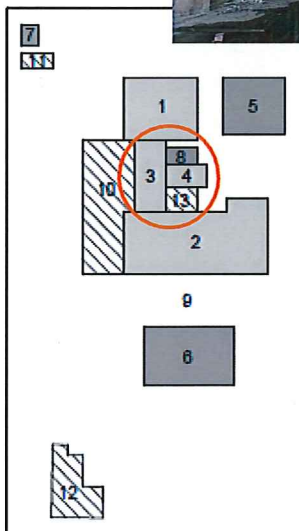
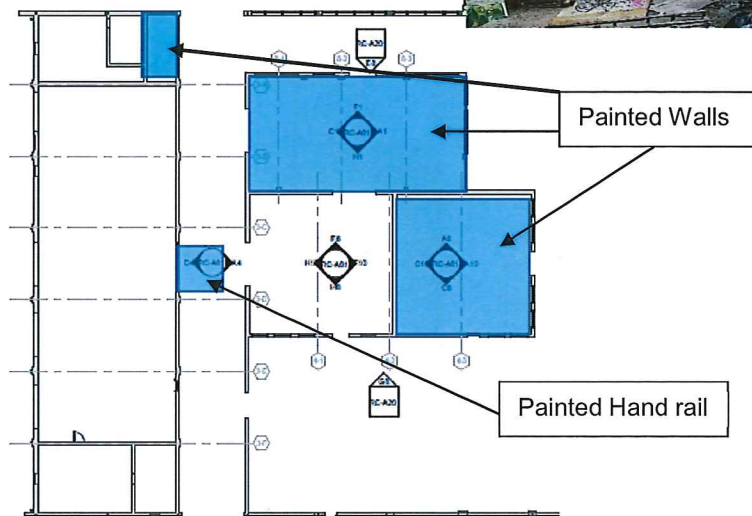
White Wall Paint Yellow Hand Rail, Green Wall Paint

Building 8 – white paint on all walls is LBP. Surface area undetermined.

Building 4 – Yellow Paint on walls is LBP. Surface area undetermined.

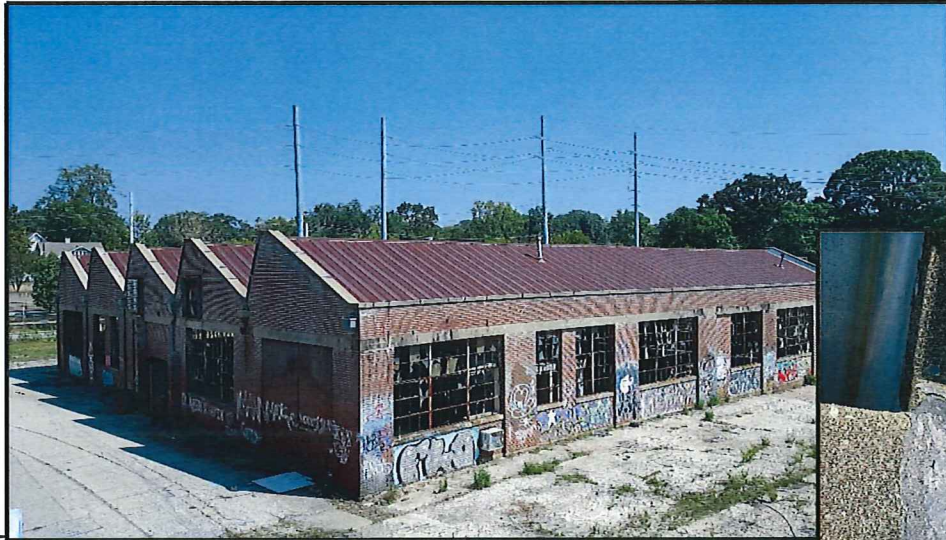
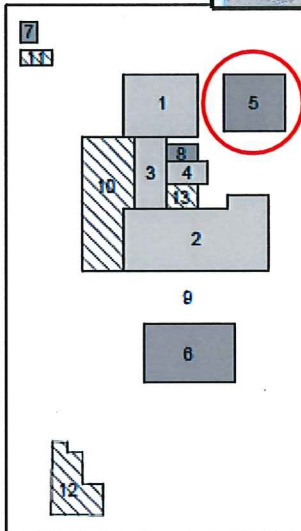
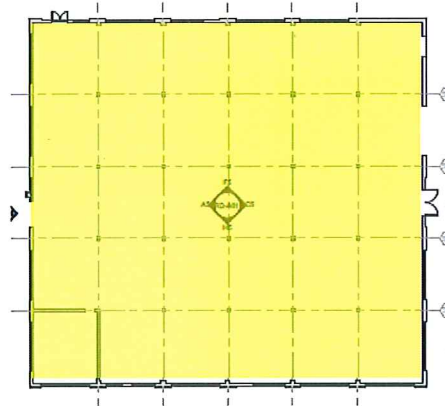
Building 5 – Outside

Roofing Felt/Paper and Mastic

Asbestos roof flashing sealant and Roofing paper

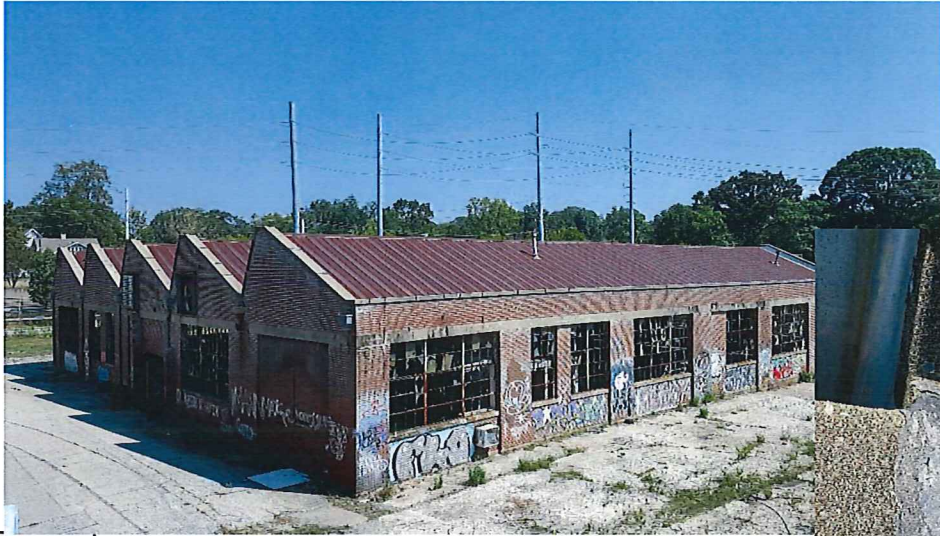
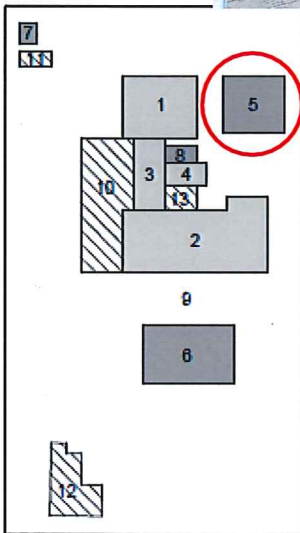
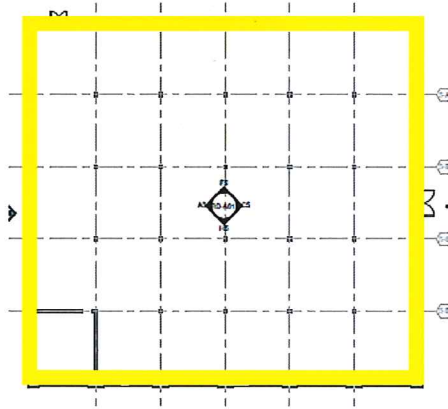
Building 5 - inside

Window Caulk

Asbestos window caulk – amount varies in each window.

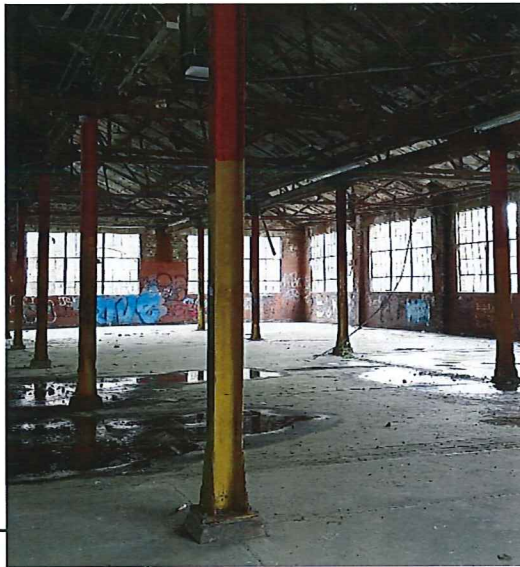
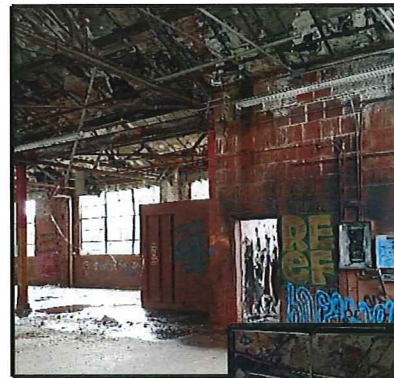
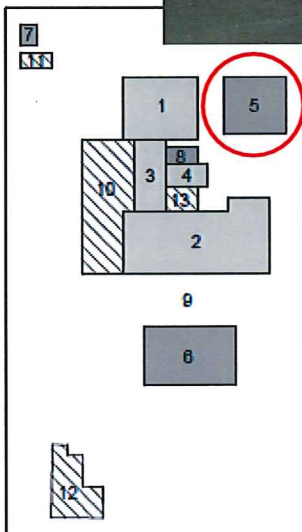
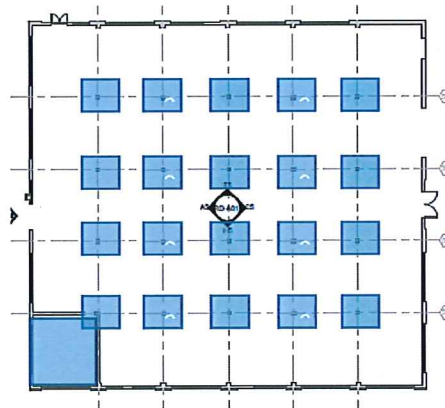
Building 5 - Inside

Steel columns, cross beams and office

Vertical Steel support columns (Red and yellow paint – 14 feet tall) – LBP.

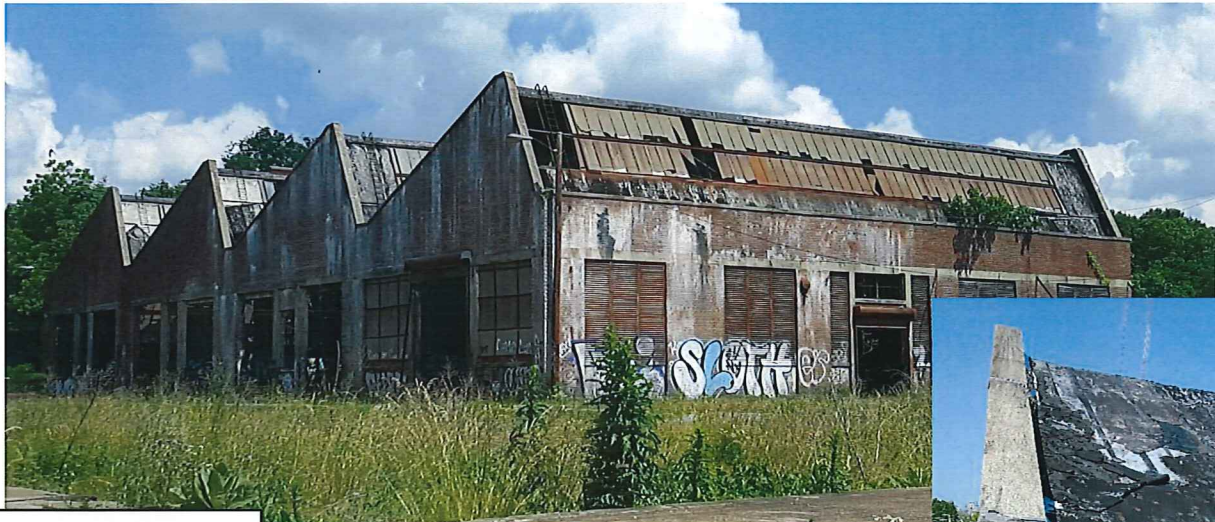
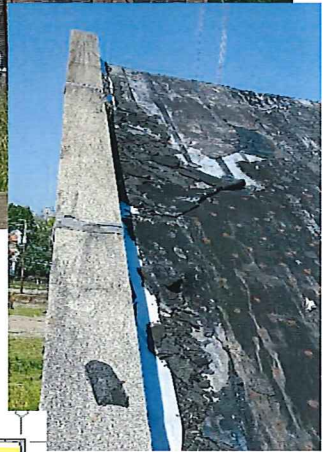
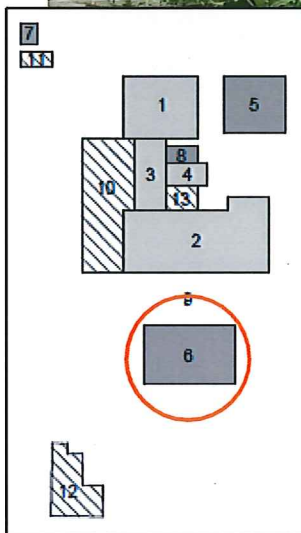
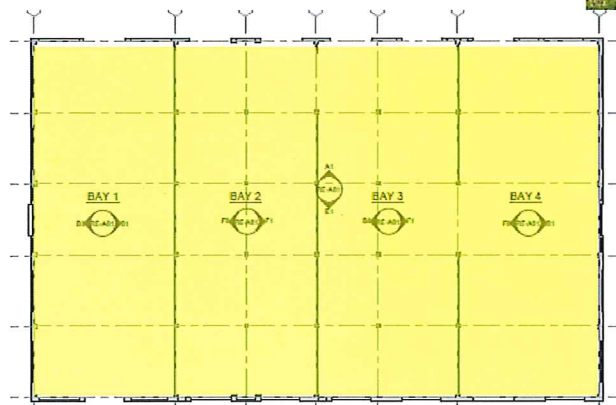
Building 6 - Outside

Roofing Paper and Sealant

Roofing system is Asbestos – tar paper and black sealant.

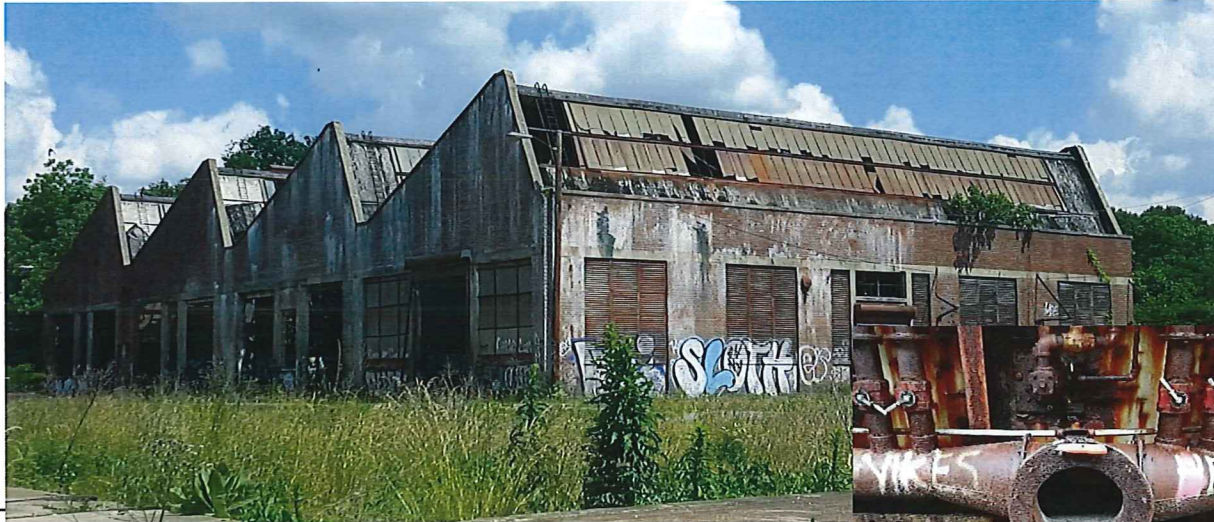
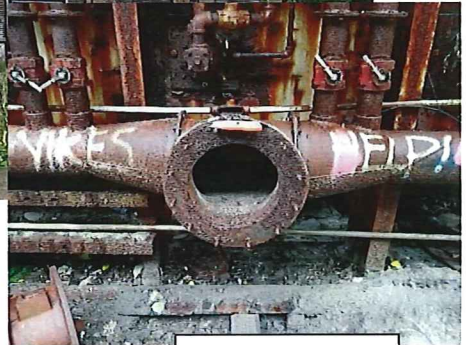
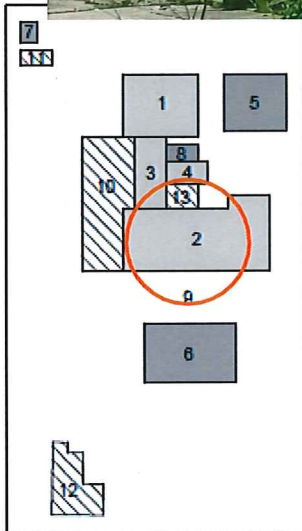
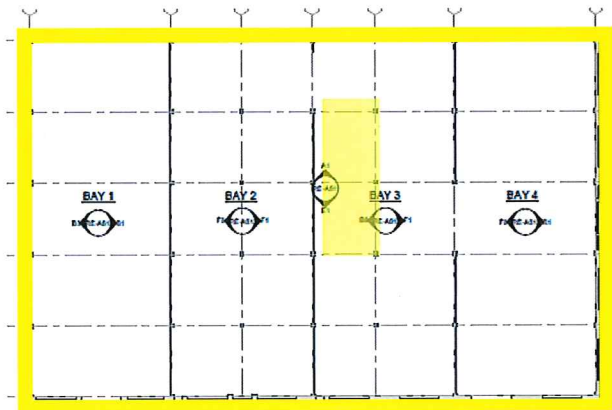
Building 6 - Inside

Window Caulk and Furnace Insulation/Gaskets

Asbestos gasket

Asbestos window caulk - various amounts in each window.

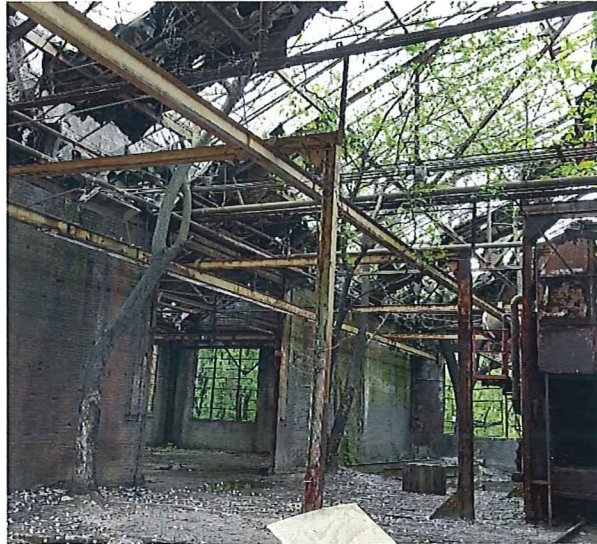
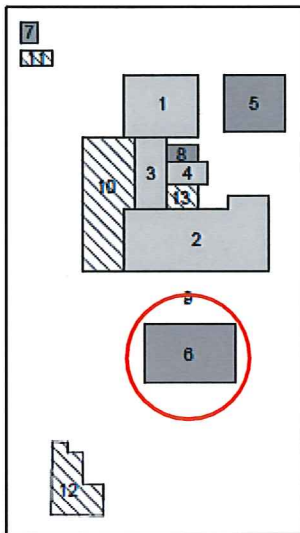
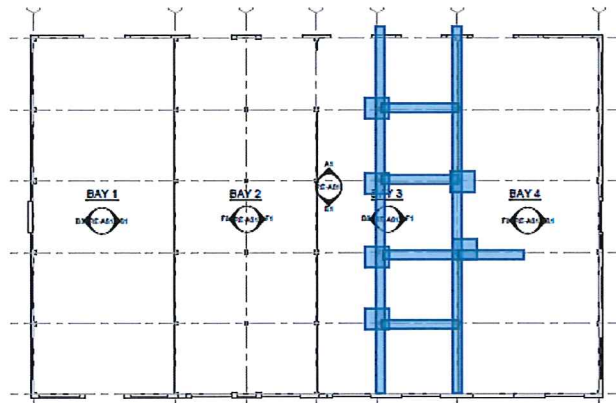
Building 6 - Inside

Inside – Yellow Steel

Yellow steel structure LBP.

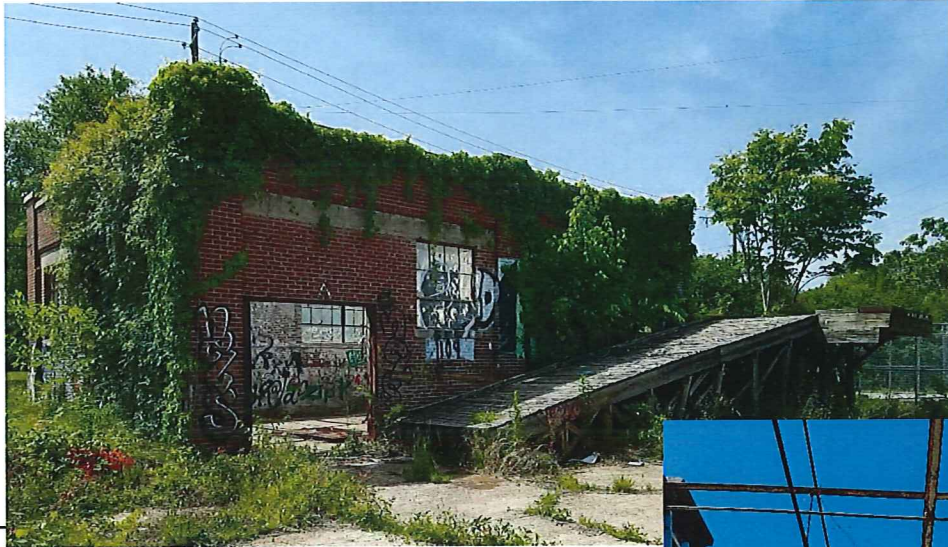
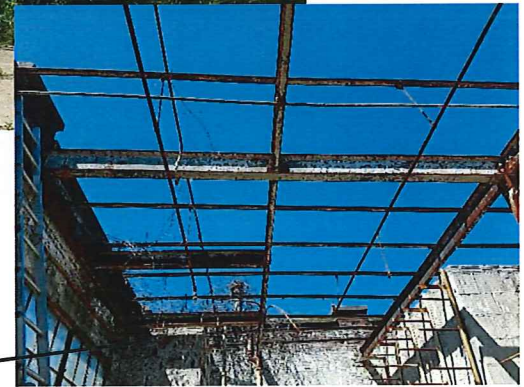
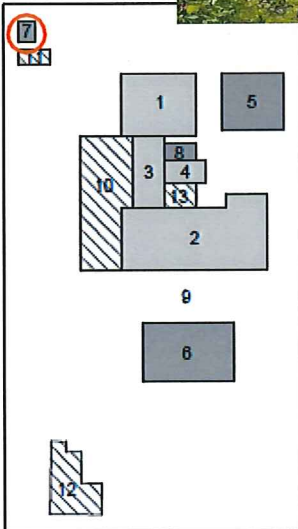
Building 7 - inside

Cross Beams – No Roof

5 I-beams (40 feet each), 14 smaller cross beams (31 feet each), and 7 minor beams (5-feet each) with white LBP across the open top.

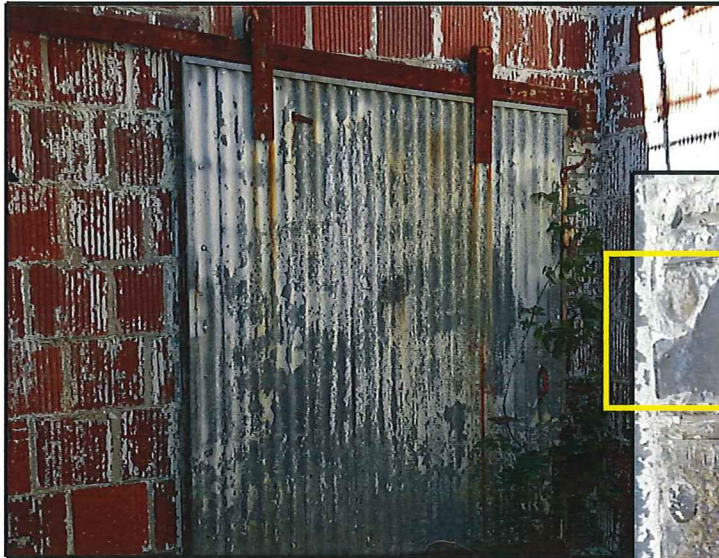
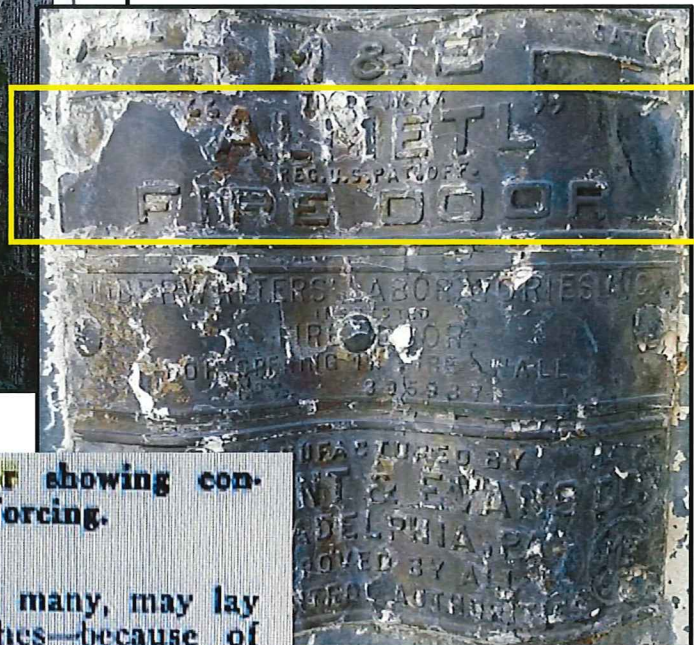
Building 7

Asbestos Fire Door

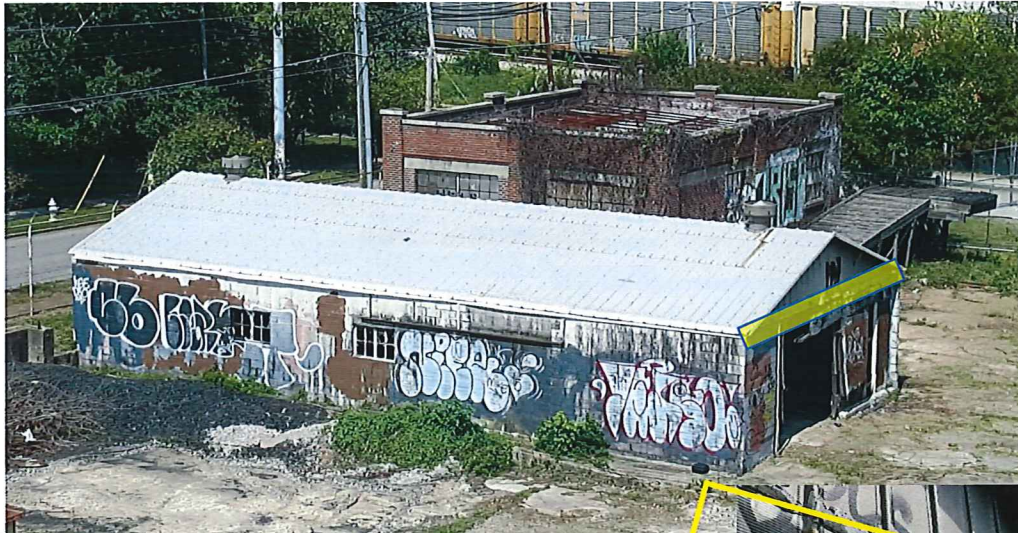
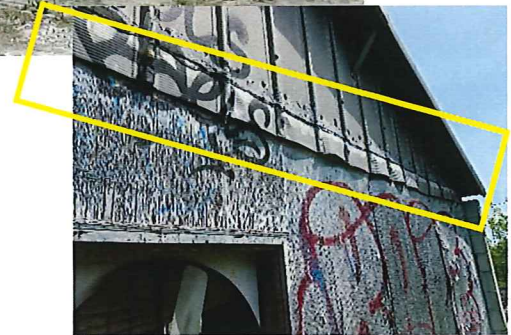
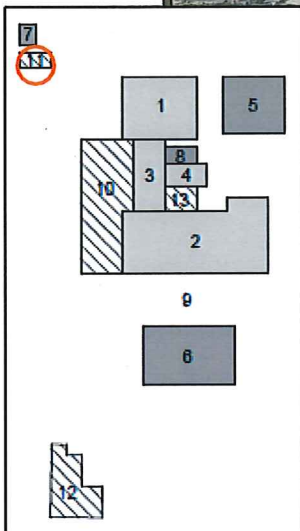
Building 11 - Outside

Mastic

ASBESTOS mastic sealant, gray, where the roof meets the building.
