DRAFT Cleanup Work Plan

Pullman Yard
225 Rogers Street, Atlanta, DeKalb County, Georgia

March 29, 2019

Prepared for:
City of Atlanta
EPA Cooperative Agreement BF-00D59517-0

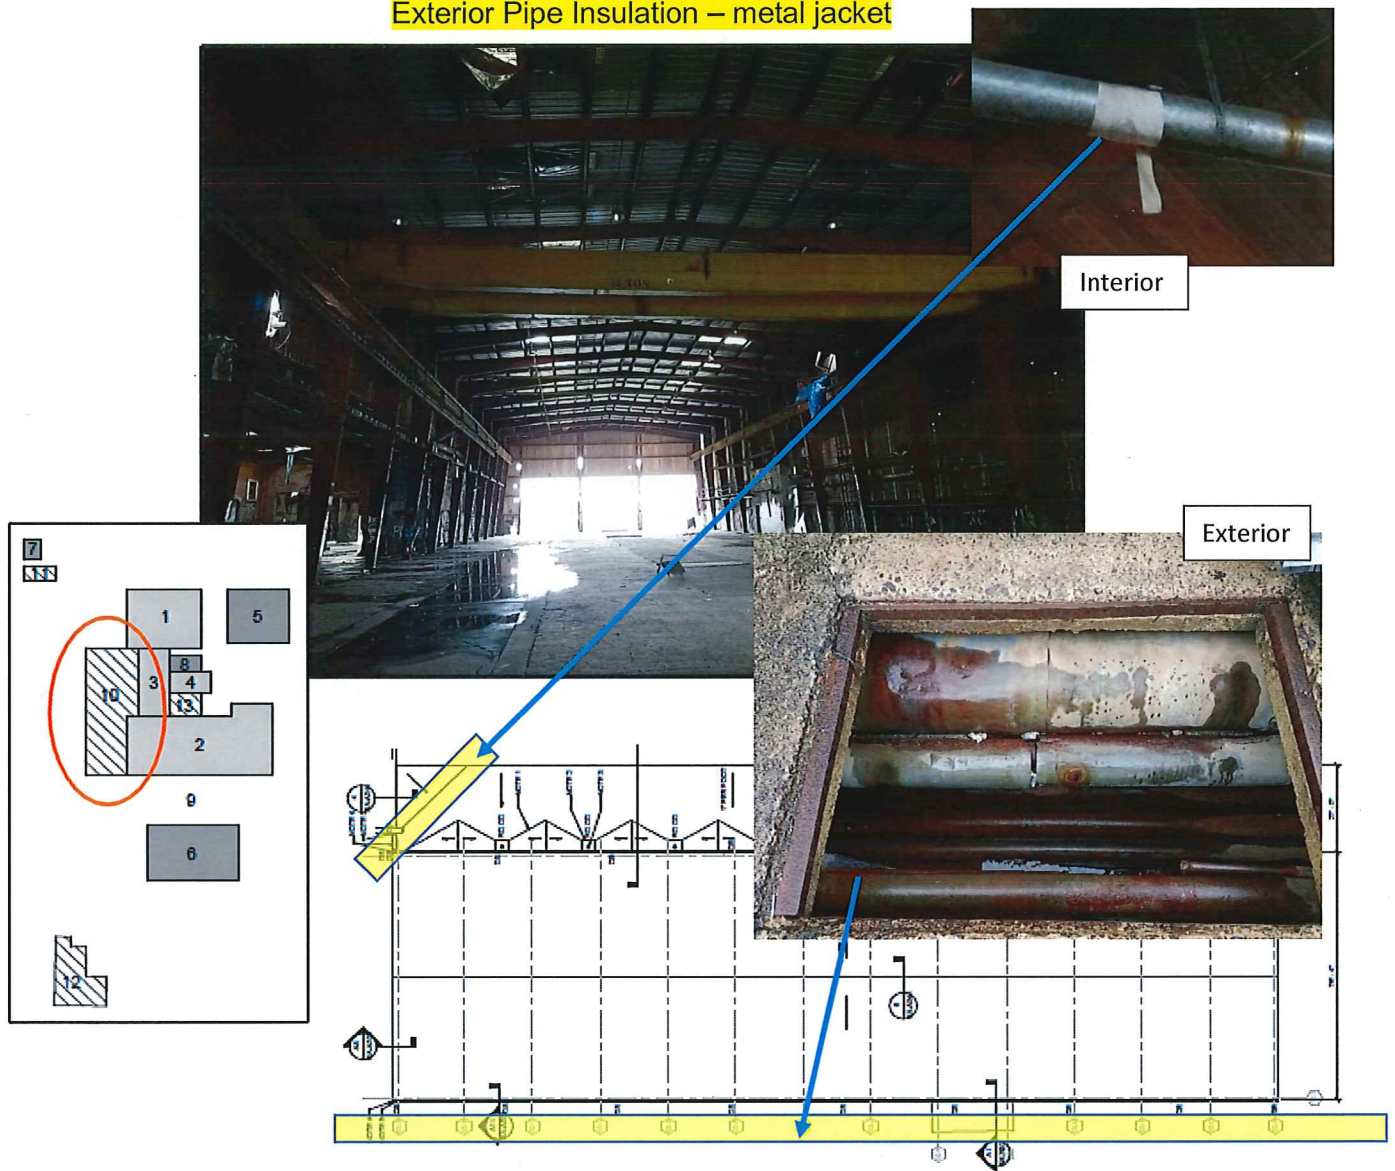
Building 10 - Inside

Pipe Wrap - two joint spots.

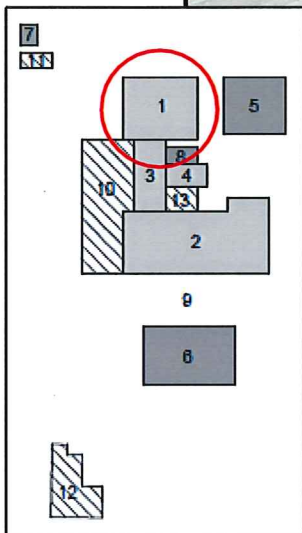
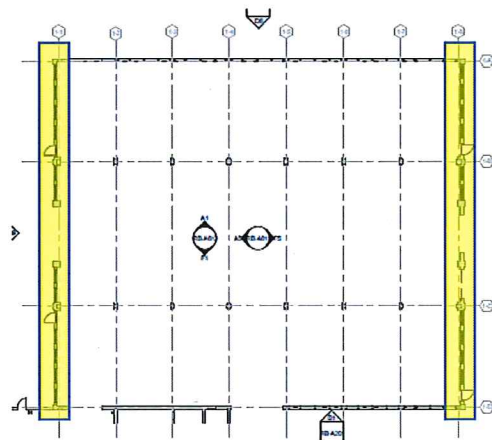
Building 1 – Outside

Asbestos roof sealant along flashing paper.

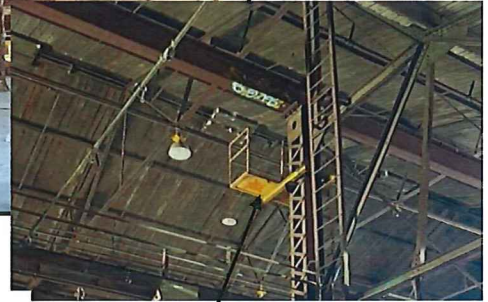
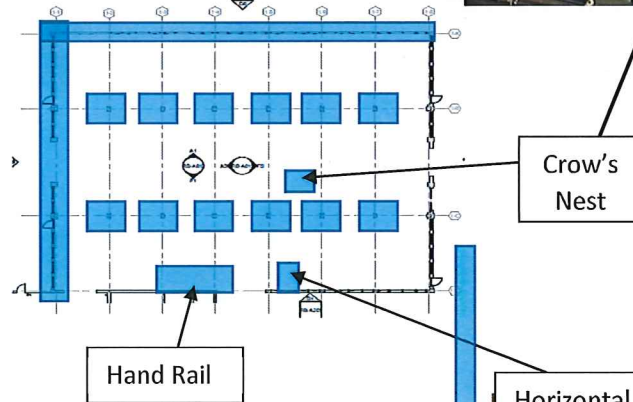
Building 1 – Inside

(12 - vertical, painted, lattice post – the lower 10 feet only).

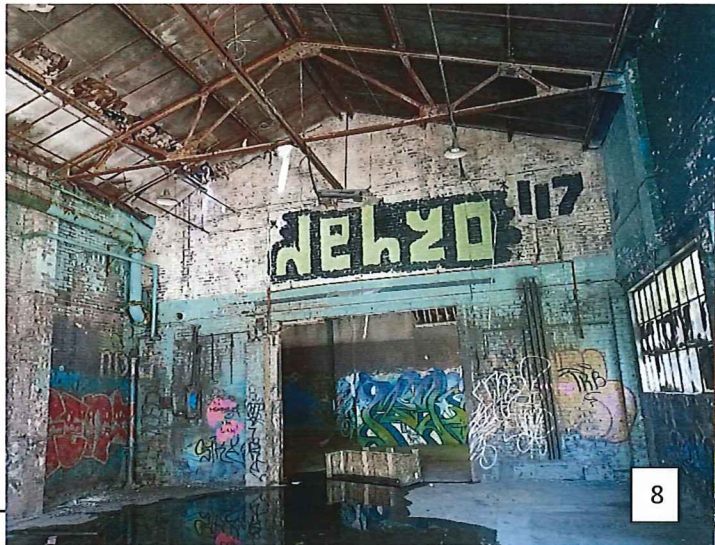
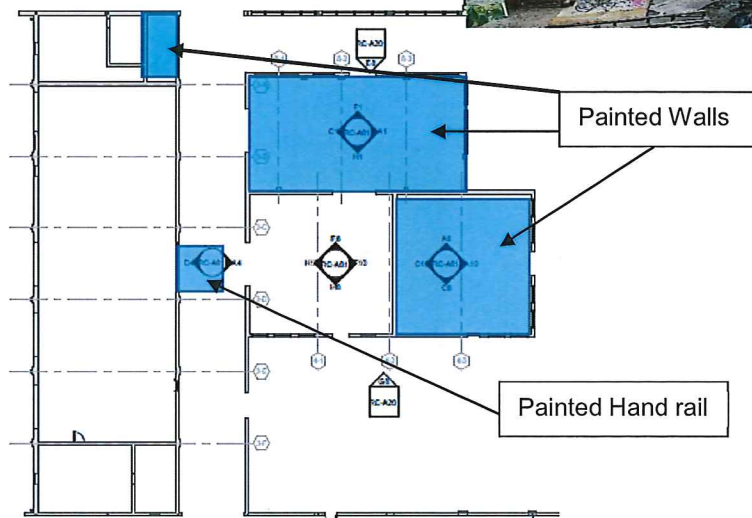
Building 8 – white paint on all walls is LBP. Surface area undetermined.

Building 4 – Yellow Paint on walls is LBP. Surface area undetermined.

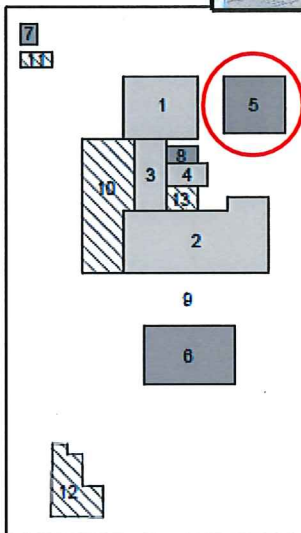
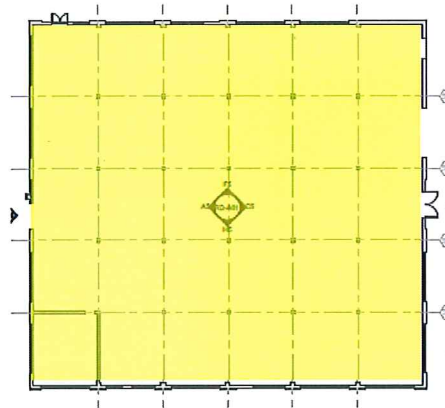
Building 5 – Outside

Asbestos roof flashing sealant and Roofing paper

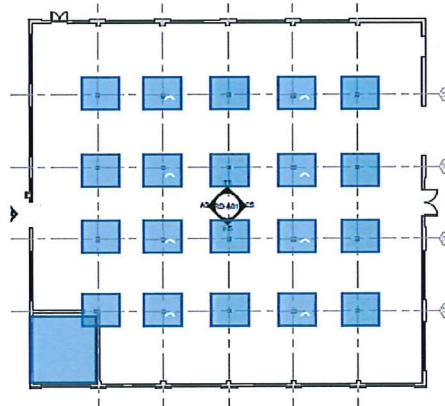
Building 5 - Inside

Vertical Steel support columns (Red and yellow paint – 14 feet tall) – LBP.

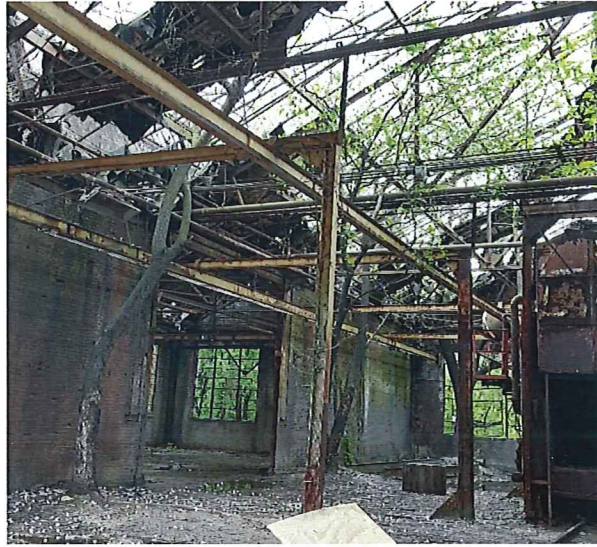
Building 6 - Inside

Yellow steel structure LBP.

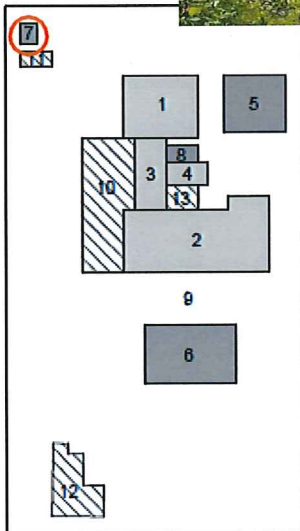
Building 7 - inside

5 I-beams (40 feet each), 14 smaller cross beams (31 feet each), and 7 minor beams (5-feet each) with white LBP across the open top.

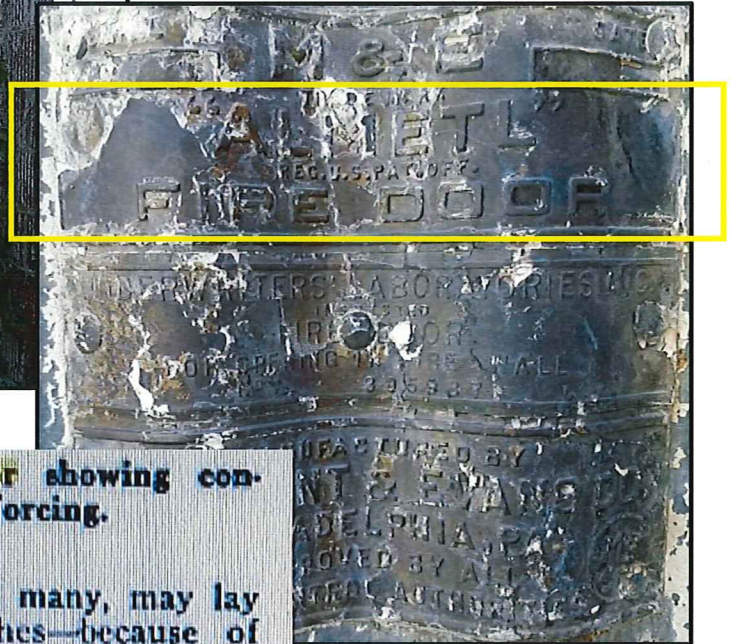
Building 7

Asbestos Fire Door

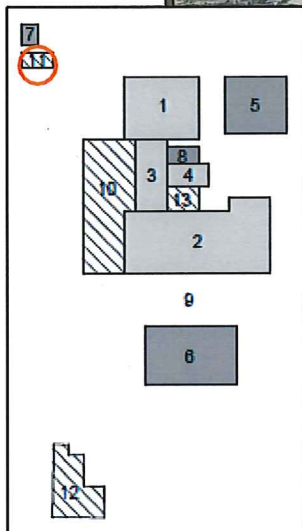
Building 11 - Outside

ASBESTOS mastic sealant, gray, where the roof meets the building.
