DRAFT Analysis of Brownfield Cleanup Alternatives

Paul Avenue 0 Paul Avenue NW, Atlanta, Fulton County, Georgia

May 1, 2020

Prepared for: City of Atlanta EPA Cooperative Agreement BF-95445109-4

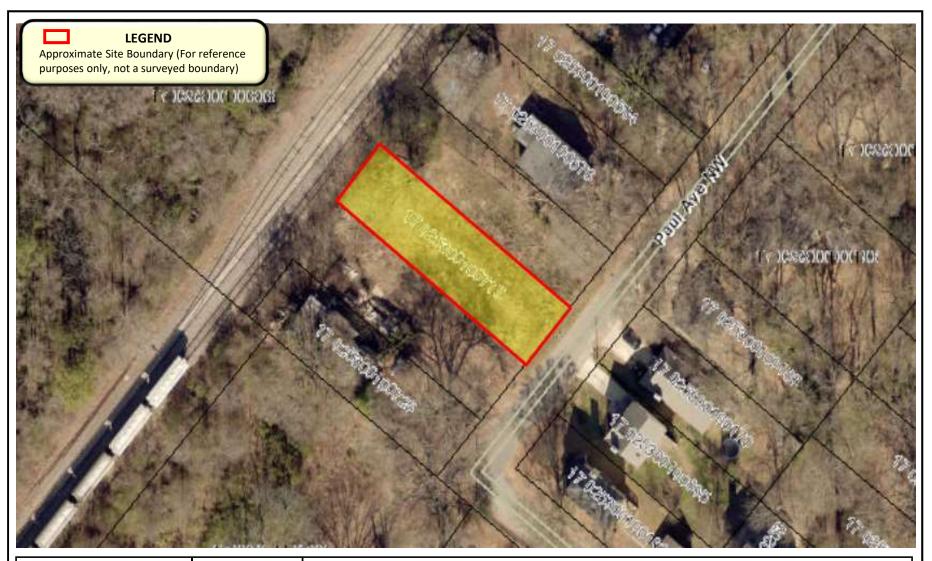
Figure 2 Site Boundary Map Source: GoogleEarth

The Subject Site consists of one parcel totaling approximately 0.2009 acres that are classified in Fulton County records as "R3 – Residential Vacant." The Subject Site is vacant, undeveloped, partially wooded land. A railroad borders the Subject Property to the northwest, and Paul Avenue to the southeast, with undeveloped land to the northeast and southwest. A Site Boundary Map is included as **Figure 2**.
