DRAFT Analysis of Brownfield Cleanup Alternatives

Pullman Yard
225 Rogers Street, Atlanta, DeKalb County, Georgia

March 22, 2019

Prepared for:
City of Atlanta
EPA Cooperative Agreement BF-00D59517-0

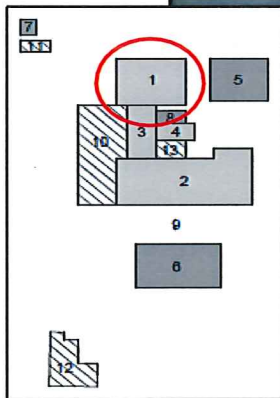
Building 1 – Inside

Lead Base Paint

Steel columns, crow's nest, hoist arms, lower wall, window jambs, yellow rail

(12 - vertical, painted, lattice post – the lower 10 feet only).

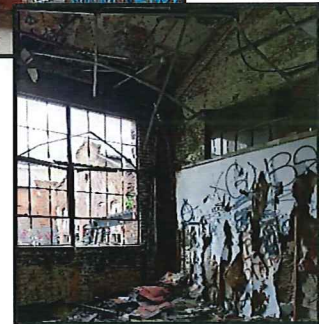
Building 5 - Inside

Lead Base Paint

Steel columns, cross beams and office

Vertical Steel support columns (Red and yellow paint – 14 feet tall) – LBP.
