DRAFT Cleanup Work Plan

Pullman Yard
225 Rogers Street, Atlanta, DeKalb County, Georgia

March 29, 2019

Prepared for:
City of Atlanta
EPA Cooperative Agreement BF-00D59517-0

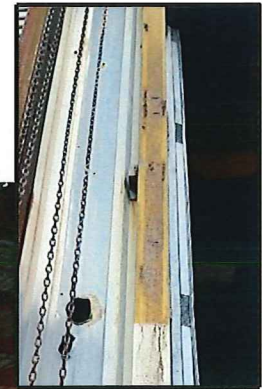
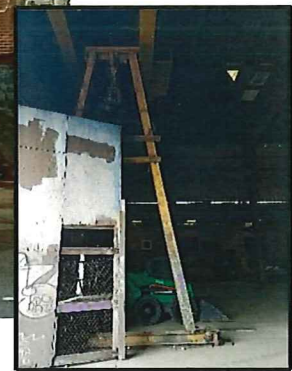
Building 10: Inside -

Lead Base Paint

Yellow Hand Rails Hoist, and Entrance Corners

LBP – Hand Rails - Painted Yellow – (Three sets of rails, Estimated: ~125 linear feet), Hoist, Water pipe (yellow paint) along west wall (Estimated: ~ 120 linear feet) and the Posts/corners at entrances on north and south ends (note yellow paint).

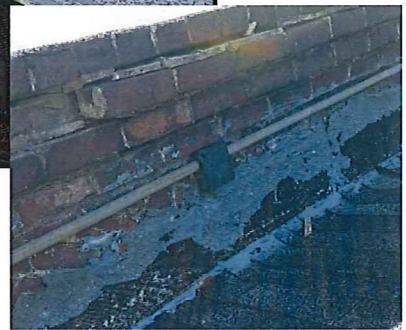
Building 1 – Outside

Asbestos

Roof Sealant (Flashing along edge and sealant)

Asbestos roof sealant along flashing paper.

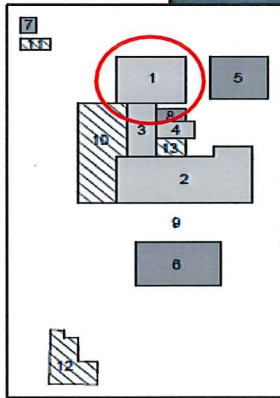
Building 1 – Inside

Lead Base Paint

Steel columns, crow's nest, hoist arms, lower wall, window jambs, yellow rail

(12 - vertical, painted, lattice post – the lower 10 feet only).

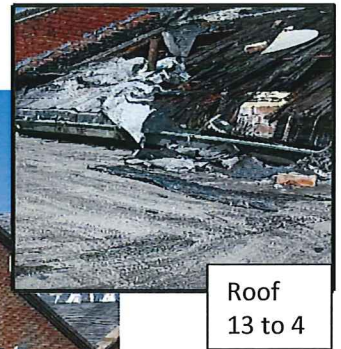
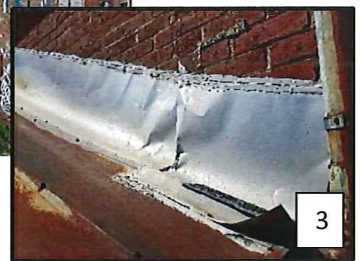
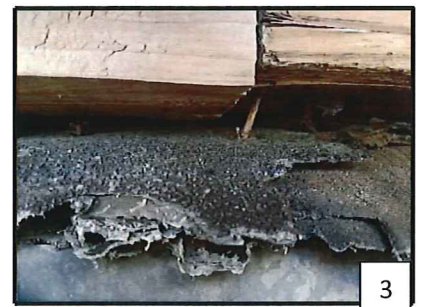
Asbestos

Roofing System

Building 13 is a flat roof – the Roofing system is Asbestos.

Estimated: Building 13 Area ~ 3040 sq. ft.

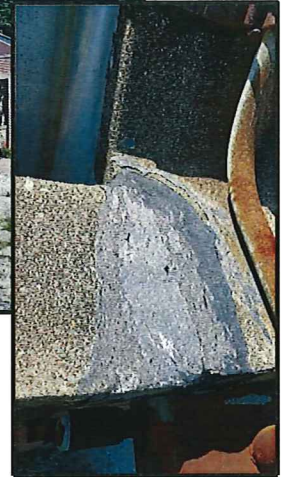
Building 5 – Outside

Asbestos

Roofing Felt/Paper and Mastic

Asbestos roof flashing sealant and Roofing paper

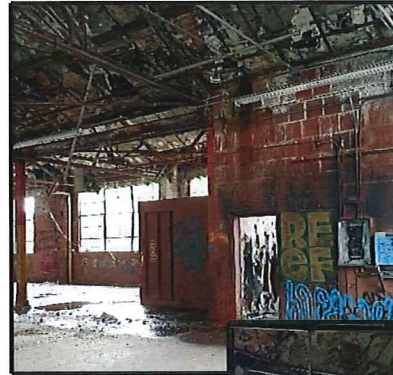
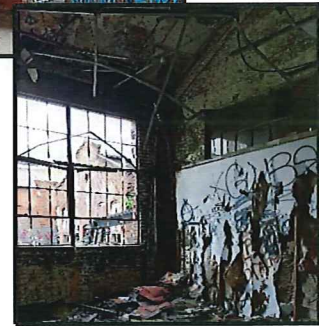
Building 5 - Inside

Lead Base Paint

Steel columns, cross beams and office

Vertical Steel support columns (Red and yellow paint – 14 feet tall) – LBP.

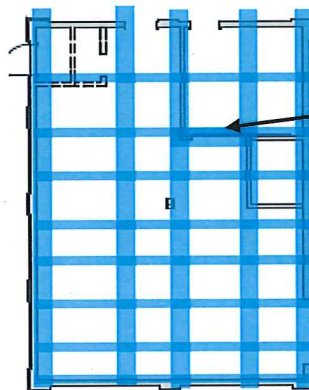
Building 7 - inside

Lead Base Paint

Cross Beams – No Roof

5 I-beams (40 feet each), 14 smaller cross beams (31 feet each), and 7 minor beams (5-feet each) with white LBP across the open top.
