# Analysis of Brownfield Cleanup Alternatives

Remerge, Inc.  
597 Auburn Avenue NE  
Atlanta, Fulton County, Georgia

January 4, 2023

Prepared for:  
City of Atlanta  
EPA Cooperative Agreement BF-95445109

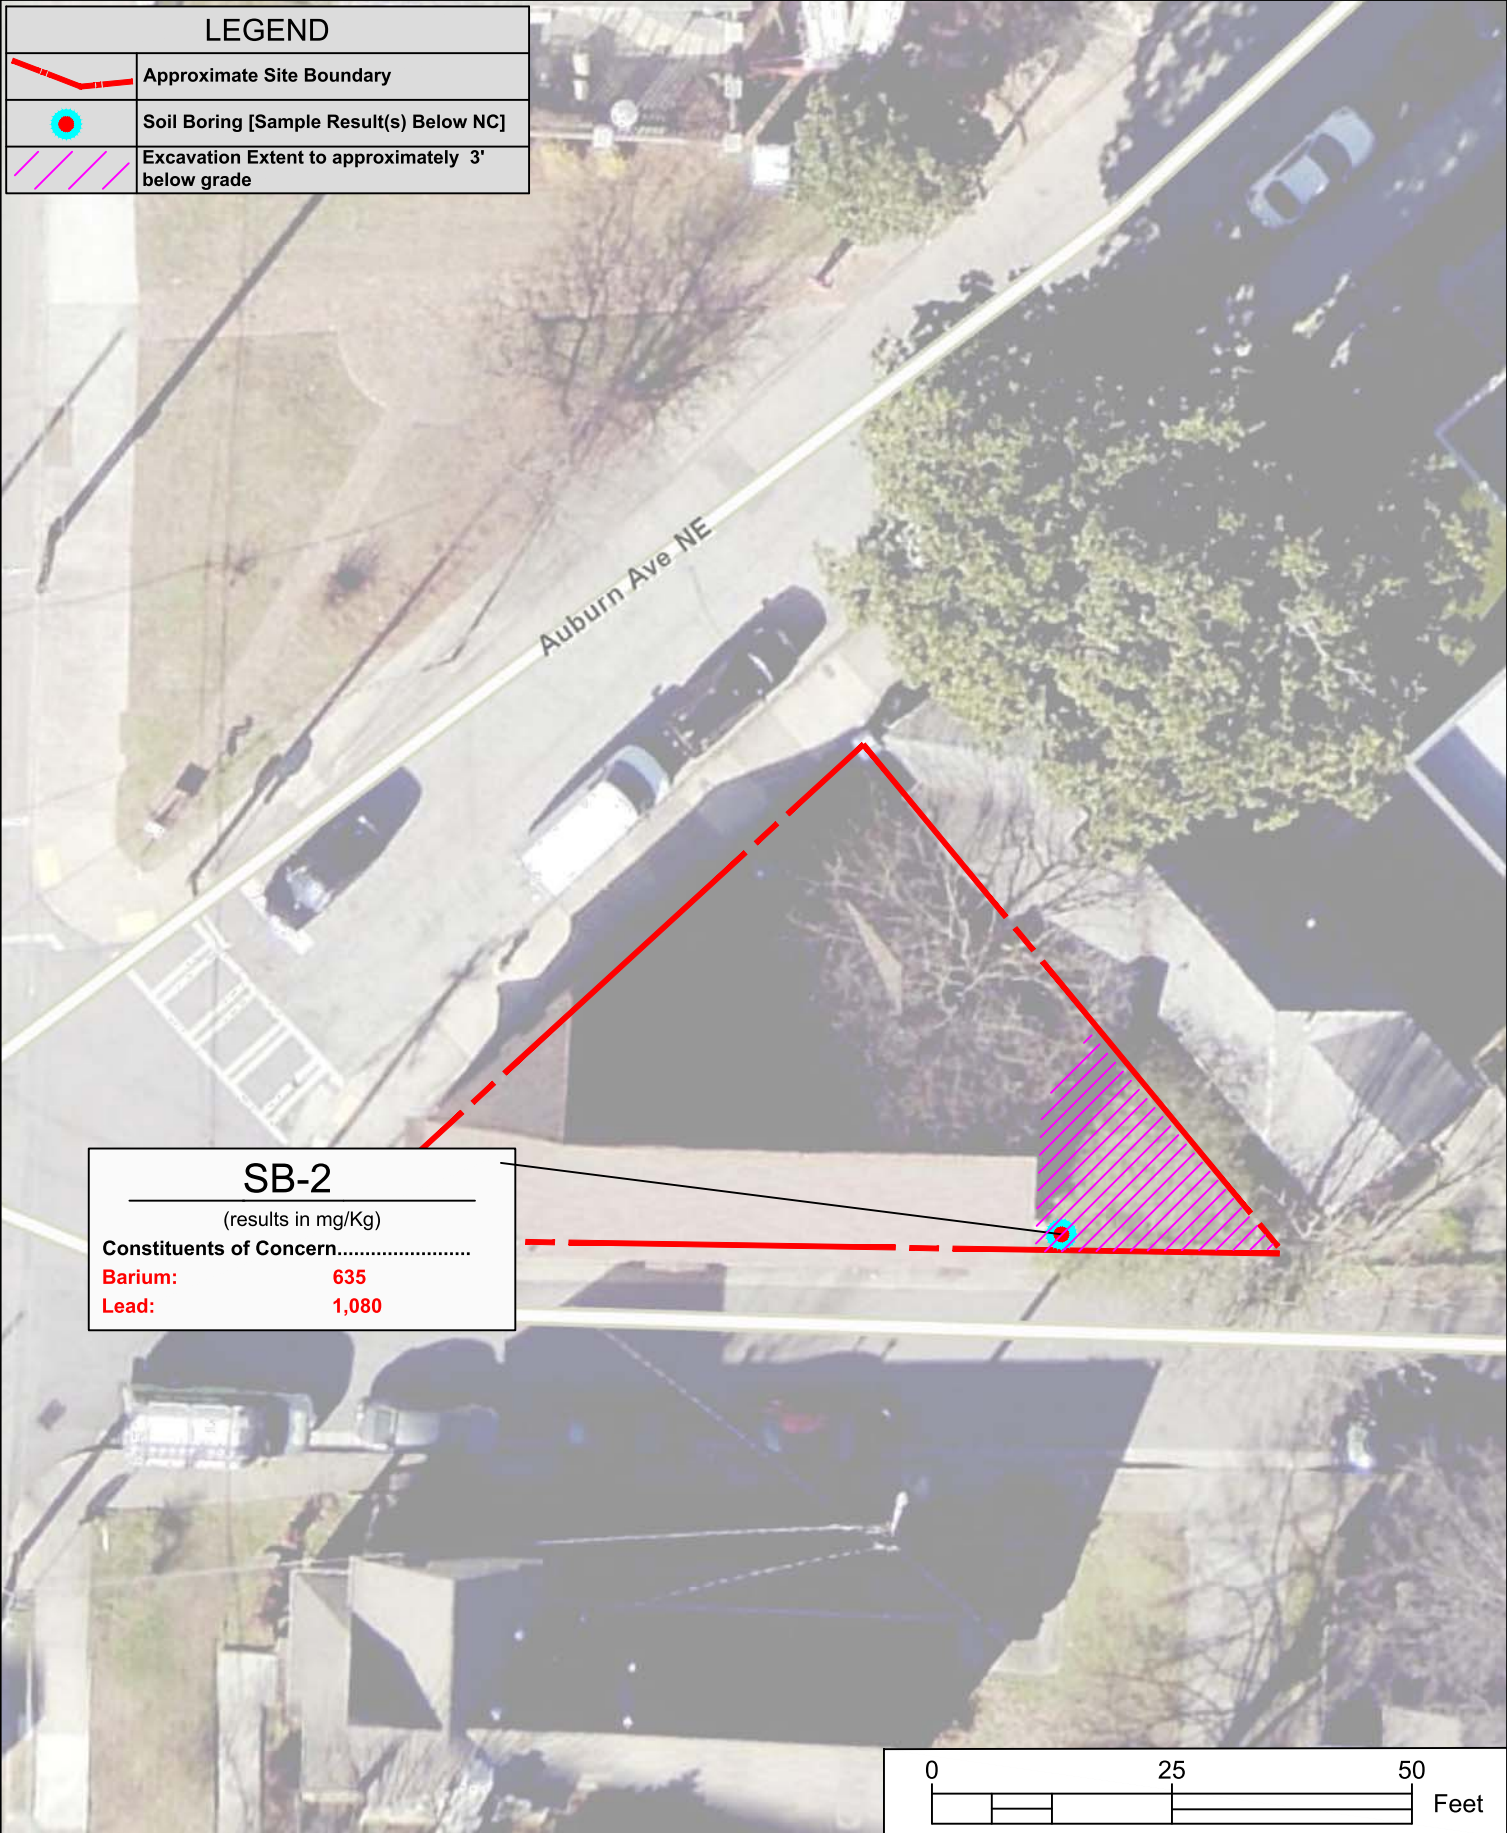
Notes: Imagery obtained from <https://fultonassessor.org/>  
 Concentrations compared to Georgia Environmental Protection Division Notification Concentrations (NC): Georgia Rules of Hazardous Site Response, Rule 391-3-19 (Appendix I)  
 Total remedial soil volume estimated at 30 cubic yards

The Subject Property is located within the Northwest Atlanta, Georgia Topographic Quadrangle of the US Geological Survey (USGS) 7.5-minute series map as shown in the Site Vicinity Map (**Figure 1**). The building located on the Subject Site is currently vacant. A Site Boundary Map is included as **Figure 2**. According to Fulton County Tax records, the subject site is currently owned by Remerger Inc (Remerger purchased the parcel in January 2022) A Soil Remedial Extent Map is included as **Figure 3**.
